# PROJECT REPRESENTATIVE'S DAILY REPORT

Pg. 1  
Report No. 102  
Date: 2015-01-15  
Day: Thursday

**Project:** Renovation and Addition to Tewksbury Town Hall

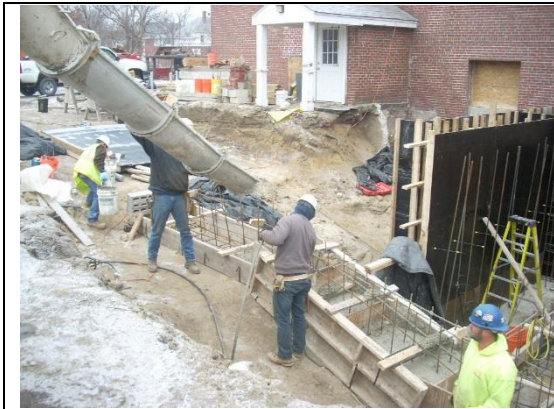
Photo showing concrete placement of exterior stair near the elevator, at the South elevation.

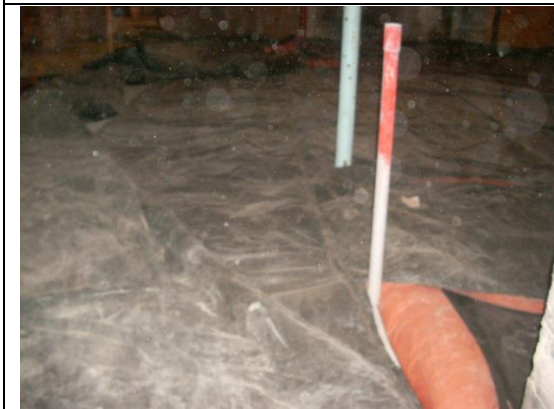
Photo showing blankets in place over the new concrete slab in the basement.

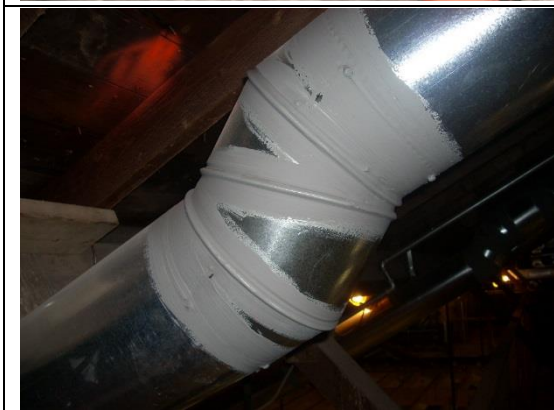
Photo showing sealed duct transition in the attic.

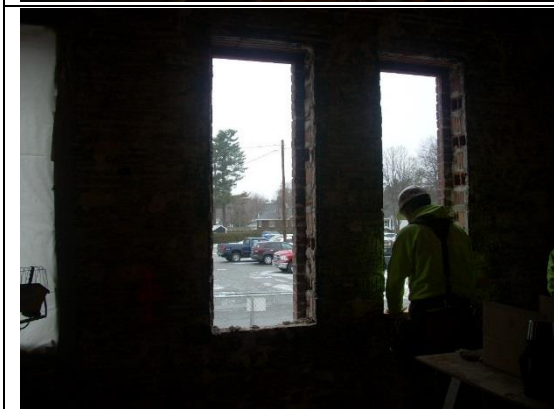
Photo showing carpenters installing window blocking.

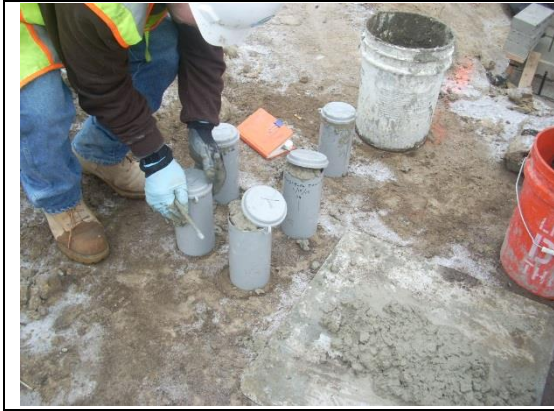
Briggs was on site to test and take samples of the concrete for the exterior stair placement:

- Slump: 4 inches
- Air: 6.6%
- 51°
